## **Results of the 2011 Hunns Lake Creek Streamwalk**

**Conducted by Cornell Cooperative Extension Dutchess County**

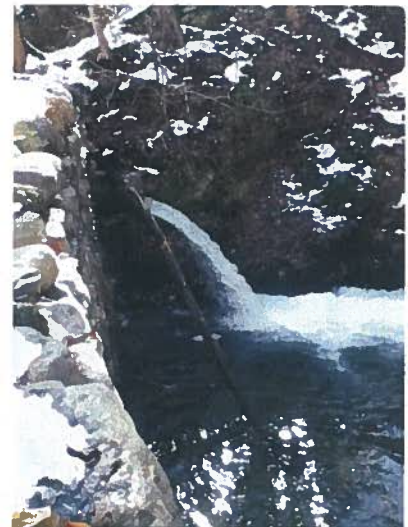
*Figure 3. A greater than 30 foot tall dam located at the end of Segment 1 of Hunns Lake Creek.*

Segment 1 had two dams located within the segment, one approximately 15 – 20 feet tall (Figure 2) and the second over 30 feet tall (Figure 3). The 30-foot dam also was large enough to effectively disconnect the stream from the floodplain downstream of the dam, which causes hydrology to receive a score of 1. Pools were present in areas of segment 1 but there were several sites assessed within the segment that had absolutely no pools present. This was actually true for the entire portion of Hunns Lake Creek evaluated for this assessment and is not uncommon to find in many other local smaller headwater streams. Segment 1 was classified as impaired according to LHCCD streamwalk method because it received a score of 3 or lower for barriers to fish movement.

Segment 2 had seven characteristics that scored a 5 or below, with the lowest scores once again being pools and barriers to fish movement. The 30 foot dam (Figure 3) at the upstream end of segment 1 also marked the beginning of segment 2. Therefore its presence gave the segment a score of 1 for barriers to fish movement. Instream fish cover and embeddedness once again received low scores, 2 and 3 respectively. The presence of the dam was also a factor that led to low scores for riparian zone and bank stability for segment 2. The area just upstream of the dam looked as if an impoundment may have once existed there. The creek appeared to have cut through layers of fine sediment (Figure 4). The absences of any vegetation directly adjacent to the stream made the banks very unstable and erodible. Nutrient

Barriers to fish movement, specifically dams, prevent the movement of fish species throughout a waterbody. Dams can have many benefits (e.g. diverting water for powering mills, storing water for livestock, storing water for drinking supplies) but many of the small dams typically found on streams like the Hunns Lake Creek have out-lived their original purpose. The financial burden of maintaining these structures and the safety issues that arise from structures that are not properly maintained can often outweigh the benefits of keeping them. Removal of these small dams not only restores the natural flow regimes for fish species and other aquatic organisms, but can also improve water quality, remove a maintenance headache, and eliminate a potential public safety hazard.

Removing a dam is not a simple or inexpensive task. Assessments and studies must be conducted to ensure the benefits far outweigh any potential cost to removing the dam. If improperly done, sediment stored behind the dam can be released downstream creating negative impacts to water quality. Homeowners cannot typically afford the large cost of an extensive dam removal projects. There are sources of funding available for dam removal projects and typically require the involvement of several partnering local and state agencies.

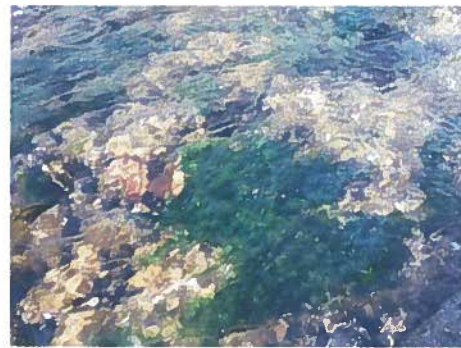
*Figure 5. Evidence of nutrient enrichment found in sections of segment 2.*

Enrichment was also visible for the first time in segment 2 (Figure 5). Segment 2 was also classified as impaired due to a score lower than 3 for barriers to fish movement.

Growth of algae in an aquatic ecosystem is an indicator of excess nutrients, such as nitrate and phosphate, and often indicative of pollution from a man-made source. These nutrients can enter waterways from failing and/or leaky septic systems, degrading sewer infrastructure, fertilizers, and animal or pet waste. The particular stretch of Hunns Lake Creek where nutrient enrichment was the most evident (Figure 5) was at least a mile long and just downstream of the old Roseland Ranch property. The ranch is no longer in operation, and there were no other visible agricultural properties immediately upstream, therefore the source a nutrient enrichment is not likely animal waste. This particular area of Hunns Lake Creek is residential. Therefore, the source of nutrients may be failing and/or leaky septic systems.

Proper maintenance of septic systems, including pumping every 3-5 years, will ensure a system is working properly and help identify issues leading to failure before they happen. Not only does this protect water quality but it is also more affordable to regularly maintain a system than replace a failing one. Municipalities can encourage residents to properly maintain their septic systems through education and the passing of ordinances that require property owners to have them regularly pumped and inspected. Ordinances can also protect streamside buffers and water quality by preventing livestock from entering streams through fences and other structures.

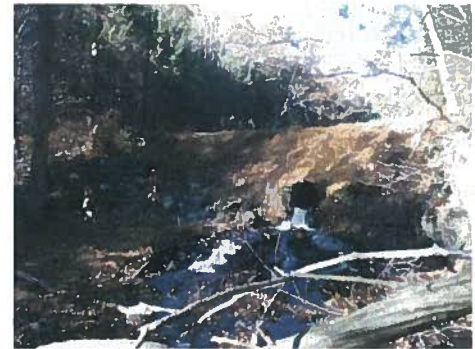
*Figure 6. Dam at the beginning of segment 5.*

segment and the creek was no longer visible from the road. The team was able to get permission to quickly take a look at the large dam and impoundment behind it, which marks the beginning of segment 5 (Figures 6 & 7).
