The Jackson Creek Streamwalk, 2007

An Assessment of the Creek with Findings and Recommendations

May 16, 2008

A joint project of
The Fishkill Creek Watershed Committee,
The Dutchess County Environmental Management Council,
The East Fishkill Conservation Advisory Commission
and others

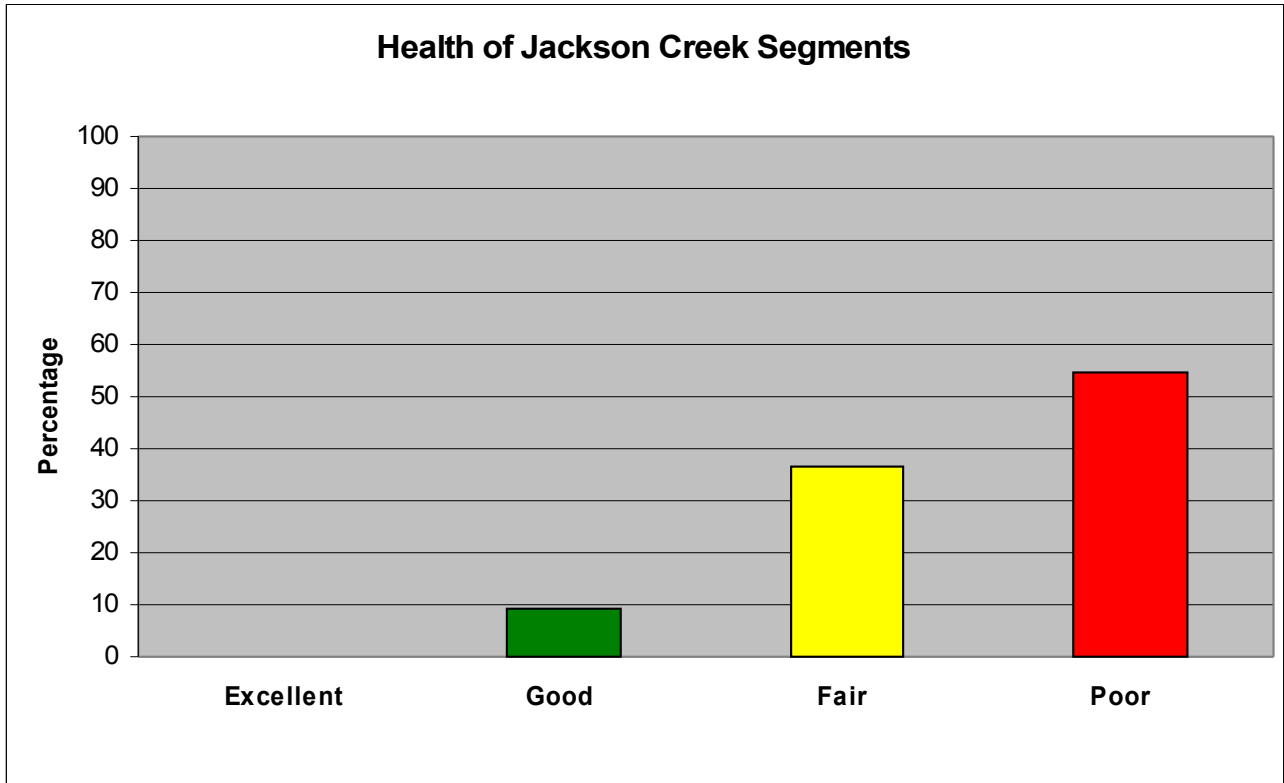
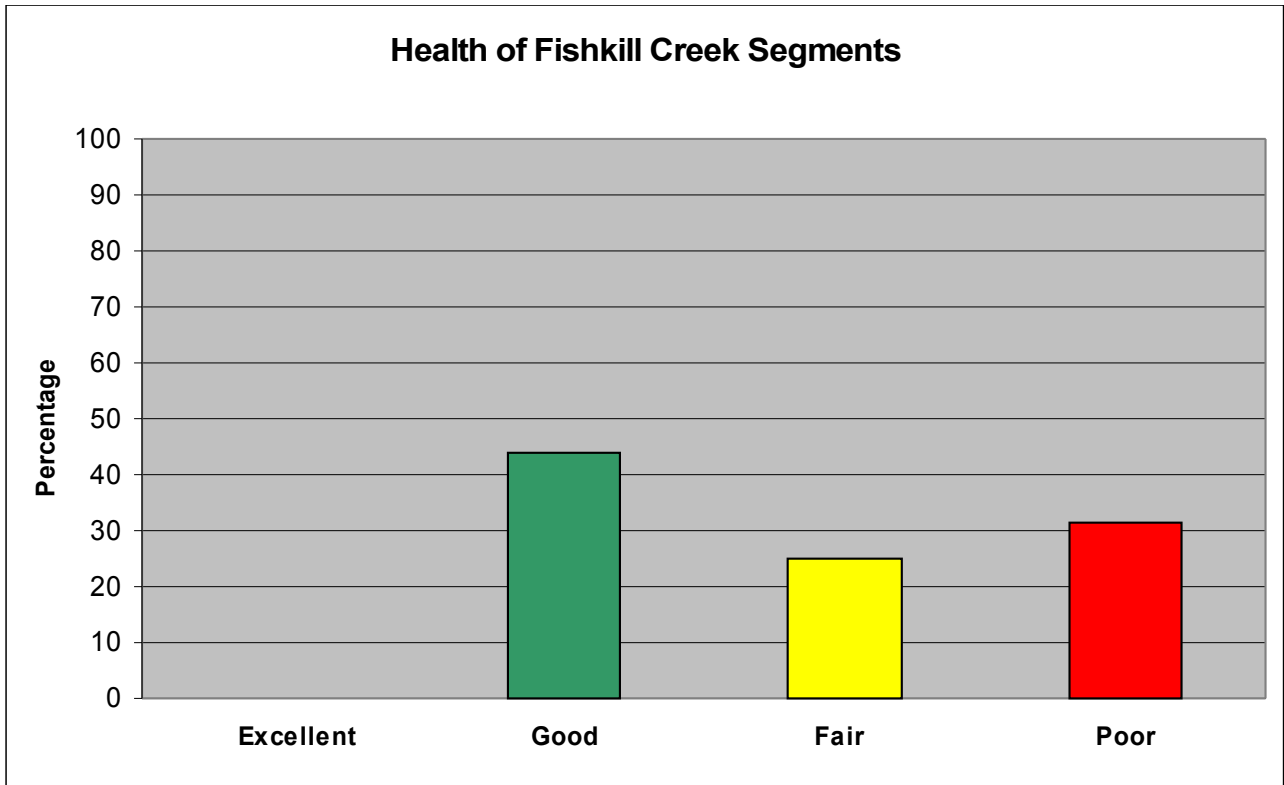
Figure 1 – Physical condition or health of stream segments on Jackson Creek (Fig. 1a) and on Fishkill Creek (Fig. 1b).

Table 1 shows the segment #, the location of the segment, the overall segment health (based on physical characteristics) and the segment score. In the LHCCD protocol, stream condition can score as excellent, good, fair or poor. None of the Jackson Creek segments were found to be in excellent condition and only one segment was considered to be good. Four stream segments were scored as fair and six segments were in poor condition. These assessments were very similar to the results of the recent Trout Unlimited study of Jackson Creek. The study of Fishkill Creek in 2004 also did not find any segments in excellent health, but the study showed a considerable number of segments in good condition. Also, the study of Fishkill Creek found a distinct geographic pattern to stream health. The segments of the Fishkill Creek found to be in good condition were located in the upstream areas of the creek, while the downstream segments of the creek were those found to be in fair to poor health. No such simple geographic pattern was observed along Jackson Creek. Instead the portions of Jackson Creek in better condition seem to correspond to portions of the creek that are heavily forested and have few residents near the creek. In both the Fishkill Creek and the Jackson Creek there is a correlation between low population density and better stream health. The segments in better condition along Jackson Creek are associated with forested areas including segments near both Rod and Gun Clubs, the forest near the Union Vale Middle School property and the forest near the mouth of the stream.

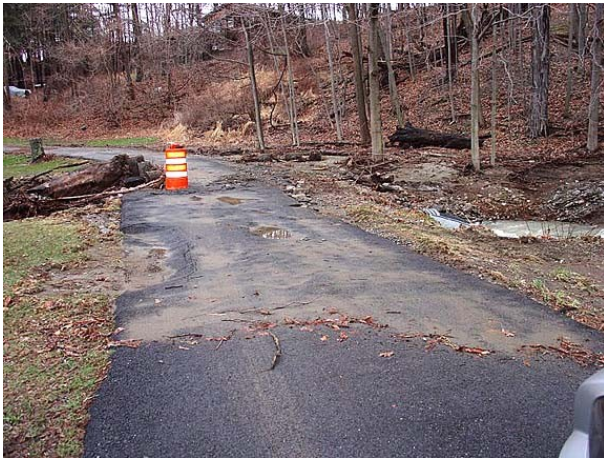
-
1. Flood damage to driveway off of Waterbury Hill Road.
 2. Flooding along Noxon Road near Arthursburg Road.
 3. Streambank erosion in Segment 10. Note the absence of shrubs and trees along the creek.
 4. Streambank erosion in Segment 11. Note the roots of trees and shrubs slowing the erosion.

Flooding- During the field work phase of this project, in October 2007, no flooding was observed. However, significant flooding occurred the previous spring at several locations along the creek. Photos 1 and 2 show some examples of flooding along Jackson Creek in April 2007. Significant flooding occurred near where Jackson Creek crosses under Waterbury Hill Road. A nearby resident described the area as “a lake” in the spring of 2007, which blocked the road and several driveways. Significant flooding also occurred on Wisseman Road, where the road crosses a floodplain. The area around the Town of LaGrange Park on Noxon Road, another floodplain, was also inundated blocking the road. A second portion of Noxon Road, near Arthursburg Road, was flooded where Jackson Creek crosses the road. The perception of many local residents seems to be that flooding has increased in recent years.

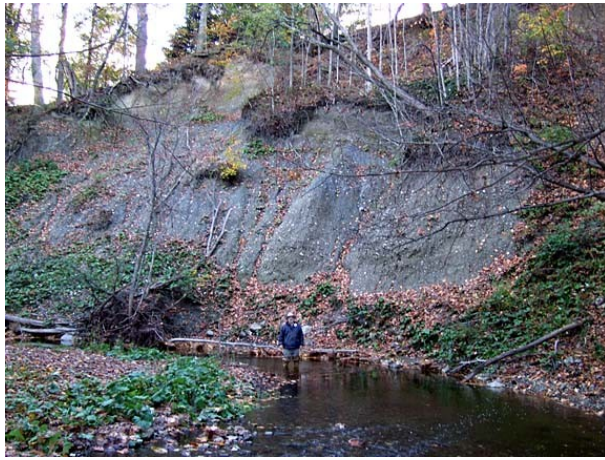
-
5. A large sand and gravel bank in Segment 5. This is one major source of sediment in the creek.
 6. An eroding streambank in Segment 3. Note that rocks and sand are entering the stream from this source.
 7. A large island of sediment in Segment 5. The island is covered with leaves.
 8. Several islands of sediment in Segment 10.

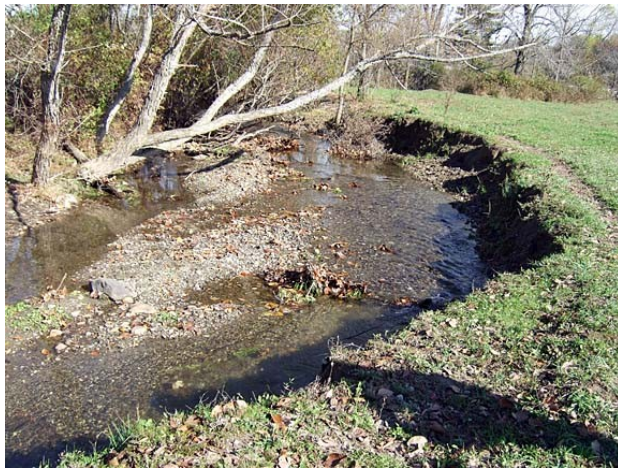
9.

Lack of Riparian Vegetation

Lack of Riparian Vegetation- Significant areas with severely damaged riparian vegetation occur in segments 9 and 10, between the Whortlekill Rod & Gun Club and Arthursburg Road. Smaller, more isolated areas of severely damaged riparian vegetation occur in segments 3, 4 and 11. Less severely damaged areas occur in segments 1 and 2. Segments with riparian vegetation in excellent condition are segments 5, 7/8 and 12. These areas tend to be heavily forested with few residences near the creek. Photos 9, 10 and 20 show examples of damaged riparian vegetation along Jackson Creek.

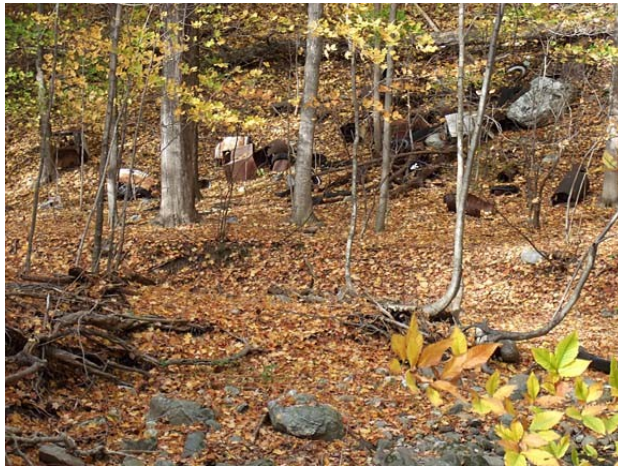
11. An old garbage dump in the woods near the creek in Segment 5.

Trash- Photos 11 and 12 show examples of litter along Jackson Creek. In general this is not a serious problem, although a few isolated parts of Jackson Creek have enough litter to warrant a clean-up effort. Two small dumps were observed, one in segment 5 and the other in segment 11, which should be removed. A small pile of asphalt was dumped on the streambank in section 4. Random trash was also observed in segments 5 and 10. The study of Fishkill Creek in 2004 found much more litter including more illegal dumps in many more places along that creek.

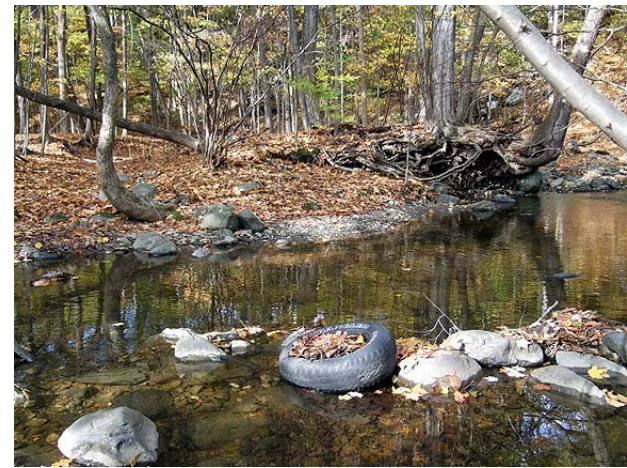
12. A discarded tire, one of several, in this part of Segment 5.

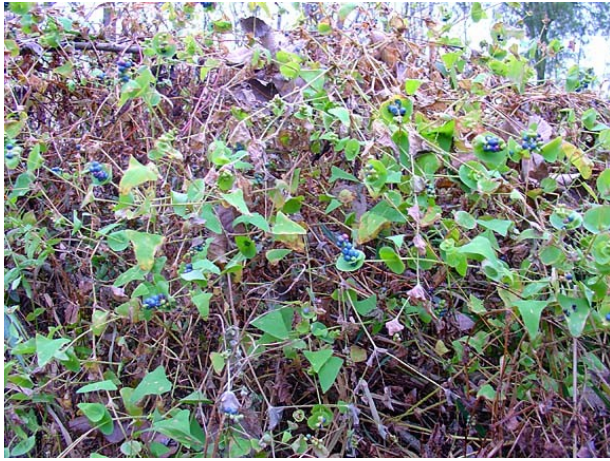
-
- 13. A close-up of Mile-a-Minute Vine in Segment 6 showing its blue berries.
 - 14. Mile-a-Minute Vine draped over several shrubs in Segment 7. This photo was taken after most of the leaves had fallen in October.
 - 15. Access point to Jackson Creek for cattle in Segment 9. Note the footprints and manure.
 - 16. Cattle drinking directly from the Jackson Creek in Segment 9.

Invasive Plants- Photos 13 and 14 show Mile-a-Minute Vine, from eastern Asia, along Jackson Creek. The invasive plant species Japanese Barberry was observed within segment 1. In all areas downstream of site 2 of segment 1, including Union Vale, LaGrange and East Fishkill, both Barberry and Multiflora Rose, native to Japan, Korea and eastern China, were found. This is probably due to the fact that the high deer population in the area browses on other plants but avoid these prickly shrubs. Both Norway Maple, native to eastern and central Europe and southwest Asia, and Garlic Mustard, native to Europe, western and central Asia, and northwestern Africa, occurred sporadically along Jackson Creek.

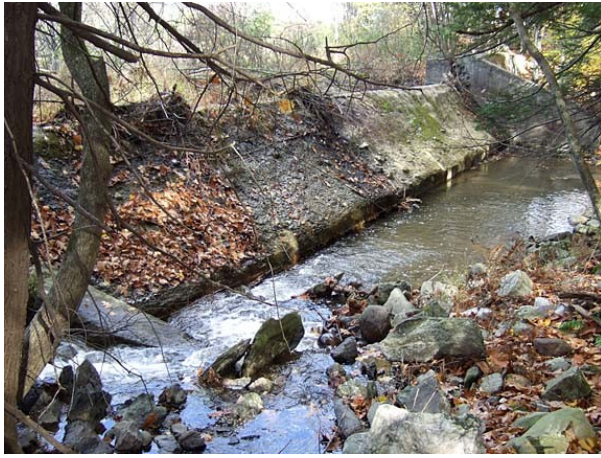
17. Dam

-
- 17. This concrete dam exists in Segment 5. Dams and some culverts prevent fish from migrating along the creek.
 - 18. Culvert with streambank erosion in Segment 2. The culvert appears too small to pass high flow events.
 - 19. A box culvert with streambank erosion in Segment 2. This also appears too small to pass high flow events.
 - 20. Jackson Creek was completely dry in this area of Segment 3. Note the lack of trees and shrubs along the creek bed.

Barriers to Fish Migration- Certain man-made objects including dams and some culverts block fish migration along Jackson Creek. Some of the culverts used to pass the creek under roads and driveways act as barriers the one concrete dam observed along the creek also acts as a barrier to fish migration. In addition the areas of the stream that were dry in the fall of 2007 act as barriers to migration.

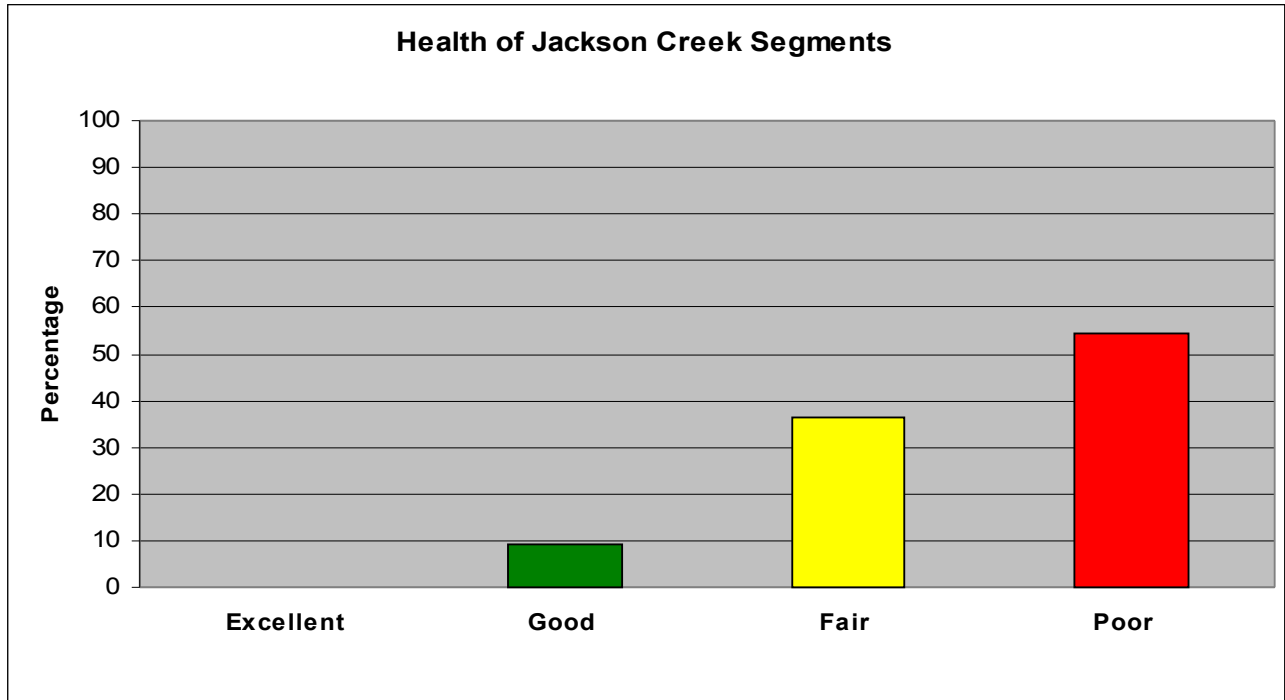
Figure 1 – Physical condition or health of stream segments on Jackson Creek (Fig. 1a) and on Fishkill Creek (Fig. 1b).

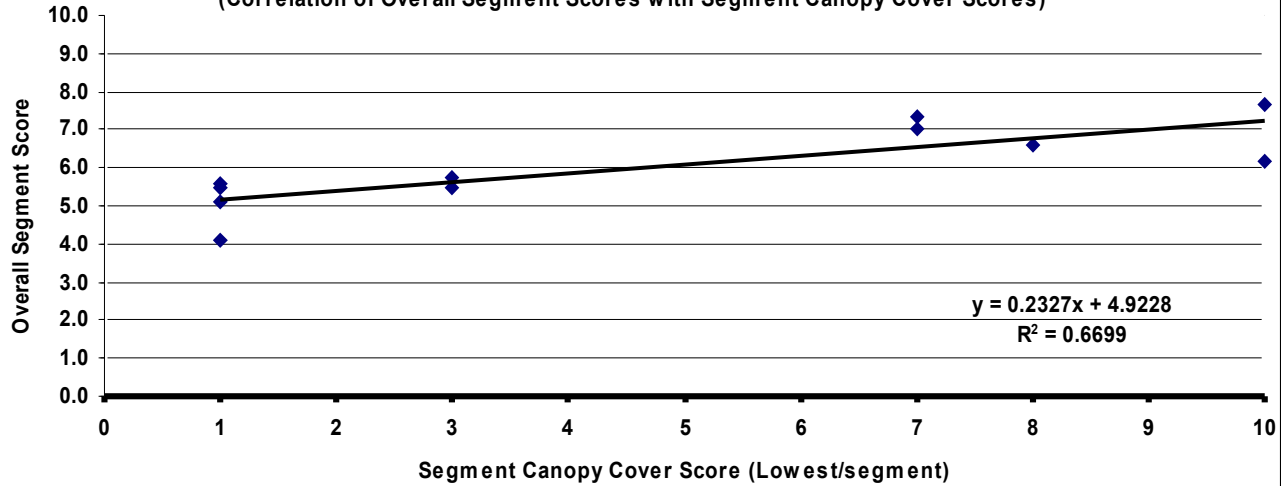
Figure 4: Jackson Creek Health vs. Canopy Cover
 (Correlation of Overall Segment Scores with Segment Canopy Cover Scores)

The correlations of Canopy Cover and Riparian Zone with stream health suggest that heavily forested areas of the stream are in better health. Bad Channel Condition is often a sign of human modification of the stream channel and usually occurs in more populated areas, suggesting that more populated areas of the stream are in worse health.

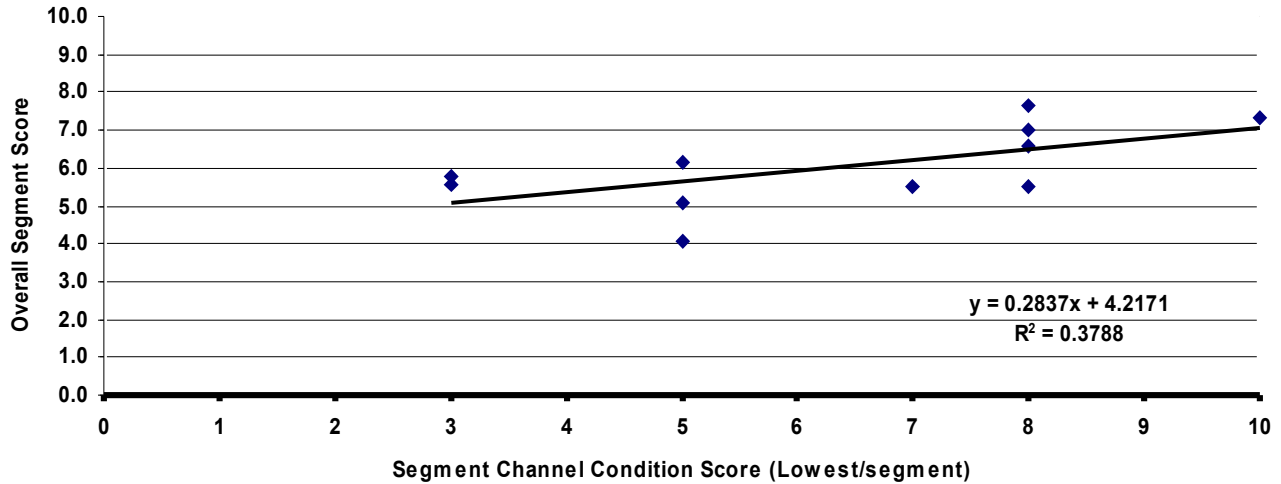
Figure 5: Jackson Creek Health vs. Channel Condition
 (Correlation of Overall Segment Scores with Segment Channel Condition Scores)

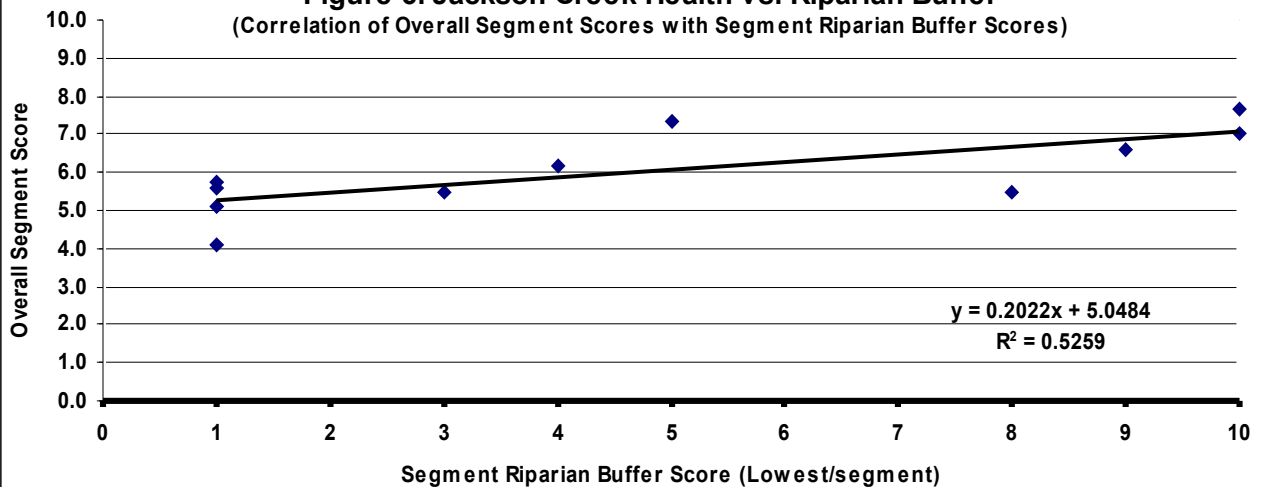
Figure 6: Jackson Creek Health vs. Riparian Buffer
 (Correlation of Overall Segment Scores with Segment Riparian Buffer Scores)

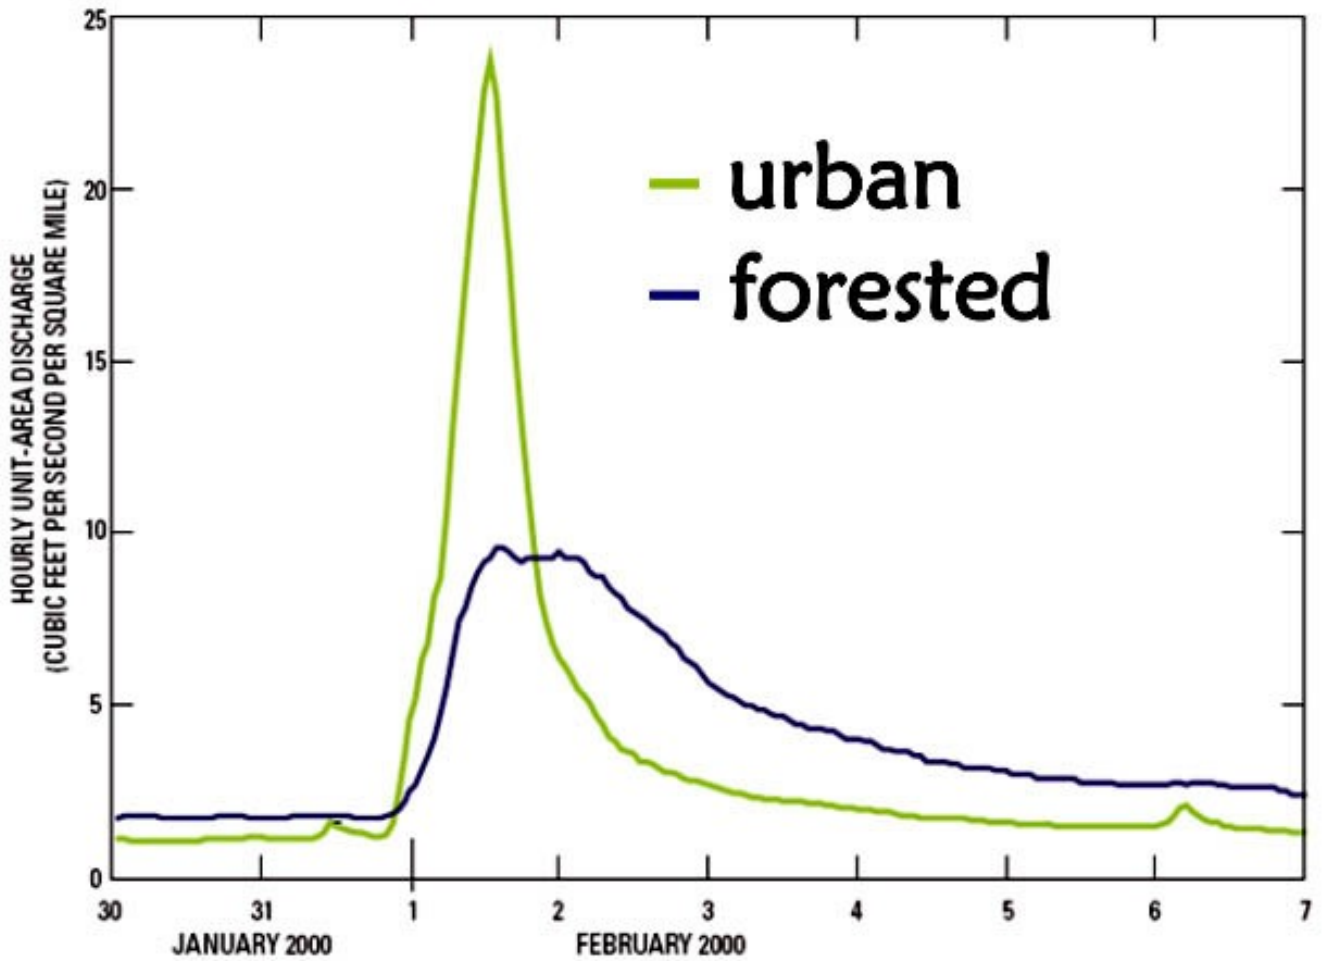
Figure 8 – The difference in stream water volume (discharge) for urban areas and forested areas after a rainfall event. Urban areas have increased stormwater runoff which may cause increased flooding.

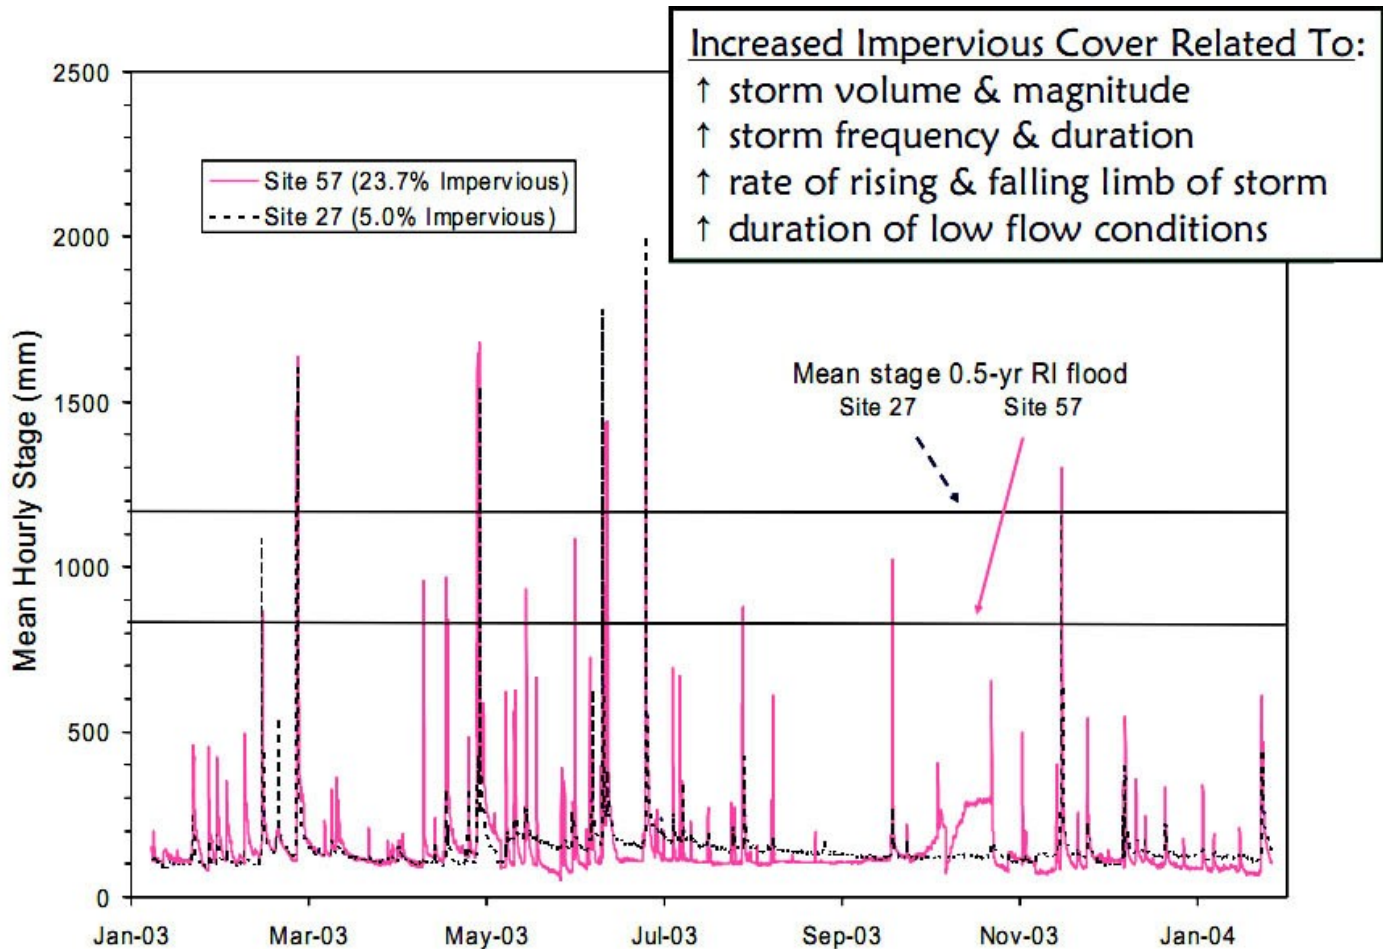
Figure 9 – Stream water height in two different watersheds in Ohio, one with 23.7% impervious surfaces and the other with 5.0% impervious surfaces. Note that the watershed with more impervious surfaces has higher stream levels and therefore increased flooding after almost every rainfall. From Roy et al. 2005.
